CAPE COD CANAL
BOURNE HIGHWAY BRIDGE

1971 CONDITION REPORT

CONTRACT NO. DACW33-71-C-0105

Fay, Spofford & Thorndike, Inc.
Engineers
11 Beacon Street
Boston, Massachusetts

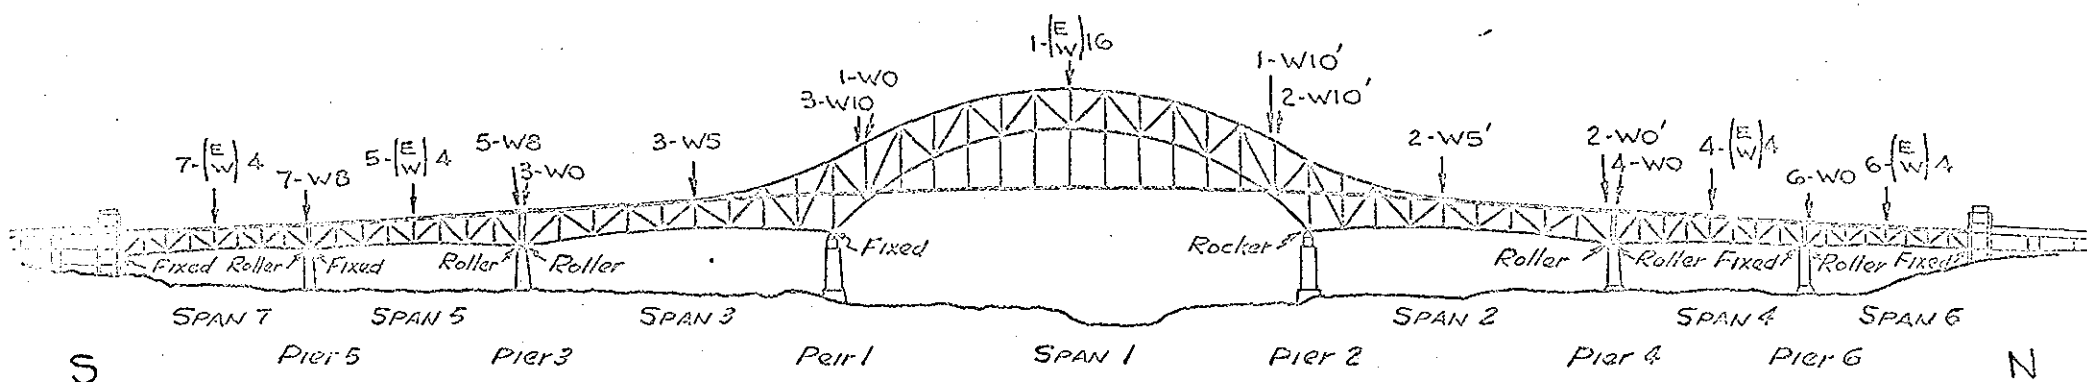
RECORDING POINTS FOR VIBRATION MEASUREMENTS
 BOURNE BRIDGE
 CAPE COD CANAL, MASSACHUSETTS
 for
 FAY, SPOFFORD & THORNDIKE, INC.
 by
 WESTON GEOPHYSICAL RESEARCH, INC.

The simultaneous recordings on opposite sides of expansion joints permit transmissibility data to be obtained from the records. The longitudinal component of motion was examined across both ends of Span 1. The displacements on Span 1 were larger in every case than the corresponding displacements on Spans 2 or 3. Comparing the end of Span 2, adjacent to the north end of Span 1, we see that the increase is by a factor of 1.1 at 4 cps and by a factor of 1.3 at 12-14 cps. Comparing the end of Span 3 to the south end of Span 1 shows the increase to be by a factor of 2.5 at 1.5 cps and by a factor of 10 at 12 cps. This suggests that the expansion joint is tighter (or possibly frozen) at the north end of Span 1 in contrast to the south end.

The lower frequency motion reported in the "extended range vibration results" table has larger displacements in the vertical direction in all cases. Spans 5 and 7 showed significantly larger vertical motion at low frequencies than elsewhere on the bridge.

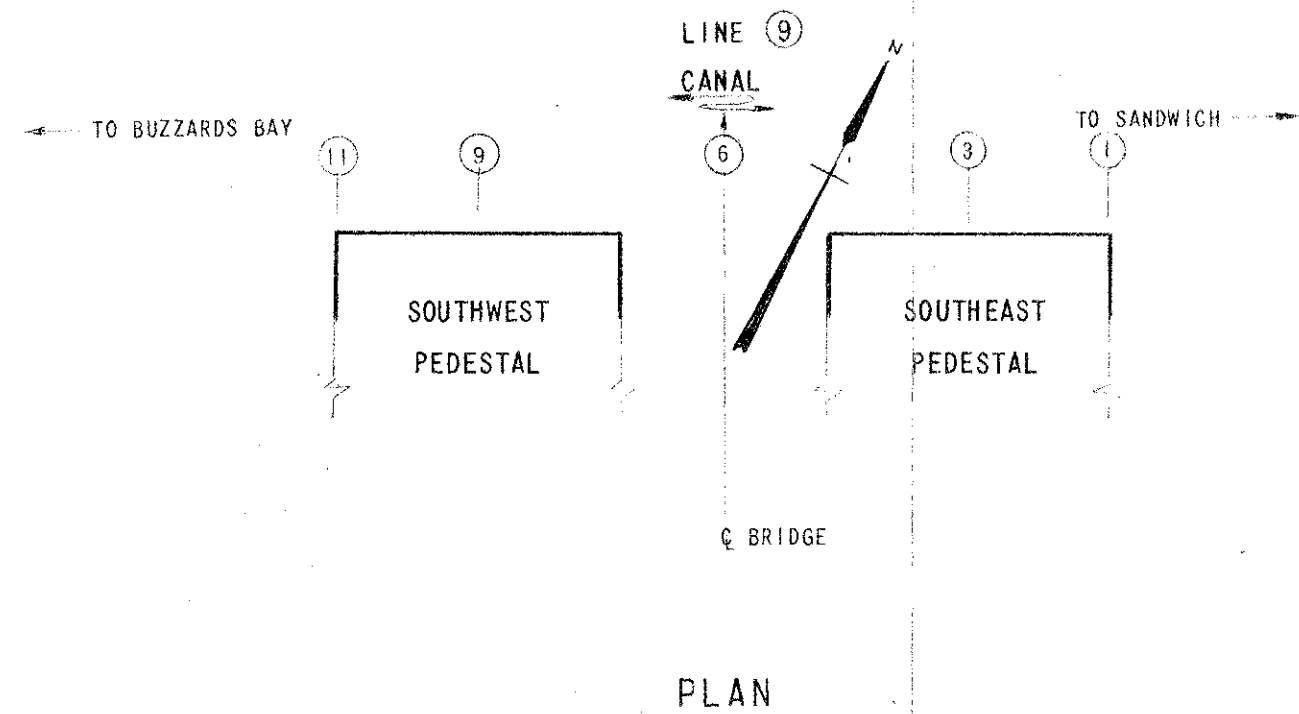
MAINTENANCE SECTIONS
PIER I

As part of the investigation of foundations, a plot has been made of the locus of high and low points from the maintenance sections taken between the years 1957 and 1969. These sections, which are a plot of channel soundings taken in the vicinity of the piers, are shown on the twelve drawings listed as data Item 4. Loci of high, low and most recent soundings are shown on Plates IV and V. This provides a graphical history of the limits of change in channel bottom adjacent to the piers during the period of years stated. These data show an average variation of approximately 5 feet in the channel bottom highs and lows with no indication of any severe scouring having taken place.
